**NCC – ACCESS EXISTING CONDITION
REPORT**

**RAY WALSH HOUSE
(REFURBISHMENT)**

Tamworth Regional Council C/-
NSW Public Works

Revision: 0
13 April 2023
Reference: 230026

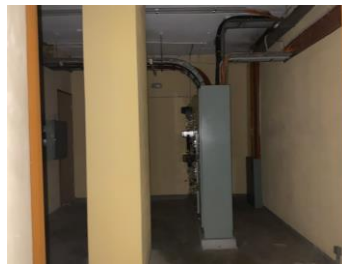
<p>Figure 22</p>

8.	C3D14 2019 Amdt 1 ref C2.13	Main switchboard	It was noted the main switch board located on ground level was not fire separated from remainder of building.	Further Information Required: The electrical consultant will need to review existing distribution cupboards and main switch boards and confirm any equipment which sustains emergency equipment which may operate in the emergency mode. Where there is equipment which sustains emergency equipment and it is proposed to be altered or located in the area of re-purposing work the bounding construction will need to be upgraded to achieve a minimum FRL of 120min.

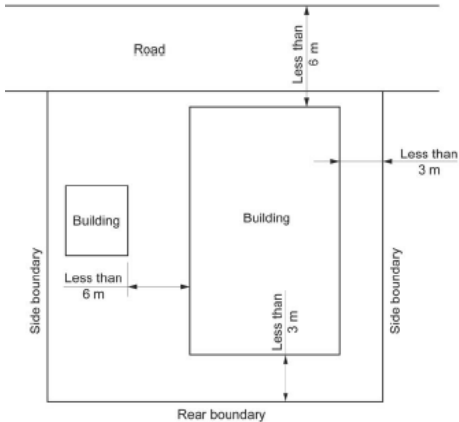
<p>Figure 24</p>

9.	C4D3 & C4D9 2019 Amdt 1 ref C3.2	<p>Protection of openings in external walls</p> <p>Opening in fire isolated exits.</p>	<ol style="list-style-type: none"> Subject to (2), openings in an external wall that is required to have an FRL must be protected in accordance with C4D5, and if wall-wetting sprinklers are used they must be located externally. The requirements of (1) only apply if the distance between the opening and the fire-source feature to which it is exposed is less than— <ol style="list-style-type: none"> 3 m from a side or rear boundary of the allotment; or 6 m from the far boundary of a road, river, lake or the like adjoining the allotment, if not located in a storey at or near ground level; or 6 m from another building on the allotment that is not Class 10 Openings in an external wall that is required to have an FRL, if required to be protected under (1), must not occupy more than 1/3 of the area of the external wall of the storey in which it is located unless they are in a Class 9b building used as an open spectator stand. <p>A window in an external wall of a fire-isolated stairway, fire-isolated passageway or fire-isolated ramp must be protected in accordance with C4D5 if it is within 6 m of, and exposed to, a window or other opening in a wall of the same building, other than in the same fire-isolated enclosure.</p>	<p>Further Information Required:</p> <p>Scaled floor and site plans are required to confirm distance from external wall, glazing and distance to fire source feature being the side boundaries.</p>

<p>Further Information Required:</p> <p>The fire isolated stairs had windows will also require protection in accordance with the requirements of this Clause. Scale floor and site plans are required.</p>

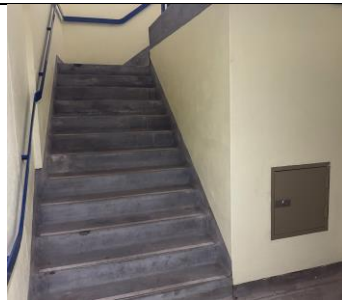
<p>Figure 58</p>

19.	D3D9 2019 Amdt 1 ref D2.8	Enclosure of space under stairs	<ol style="list-style-type: none"> 1) Fire-isolated stairways and ramps — If the space below a required fire-isolated stairway or fire-isolated ramp is within the fire-isolated shaft, it must not be enclosed to form a cupboard or similar enclosed space. 2) Non fire-isolated stairways and ramps — The space below a required non fire-isolated stairway (including an external stairway) or non-fire-isolated ramp must not be enclosed to form a cupboard or other enclosed space unless— 	<p>Further Information Required/ Does Not Comply/Rectification works Required</p> <p>Enclosures are not permitted under fire isolated stairs. A locked cupboard was identified within the fire isolated passageway from car park towards peel street exit.</p> <p>Confirmation is required what this is used fir and is this can be blocked up as part of refurbishment works.</p>

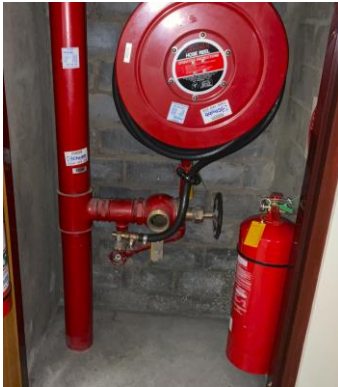
<p><i>Figure 84</i></p>

26.	E1D2 2019 Amdt 1 ref E1.3	Fire Hydrant System	<p>The Ray Walsh building is noted as being serviced by primarily internal hydrant outlets. A number of compliance issues matters requiring further investigation were noted as follows;</p> <ul style="list-style-type: none"> a) The hydrant system is Ordinance 70 which is no longer supported by FRNSW. b) Internal fire hydrants where not located within fire isolated stairs but directly adjacent in cupboard. Some of these locations where fire separated from remainder of the building however not reflective in all locations. c) The fire hydrant booster assembly serving the building was locked at the time of inspection and is located on a flight of steps adjacent to the Peel street entry <10m (7.5m) from building without fire shield. The following could not be confirmed; <ul style="list-style-type: none"> + Statutory signage is required to be upgraded including Block plans, + Fire Hydrant Booster signage, + Test and Boost pressure. + The booster does not appear to be provided with a non-return valve noting that the booster appears to only be provided with an isolation valve + Direction of flow of the water is to be shown on the booster assembly + Angle of Outlets appear to be more than 35 deg + Could not be determined if the lock provided to the tamper chain was provided with a 003 d) The Hydraulic Engineer is to confirm the performance of the existing hydrant 	<p>Does Not Comply/Rectification works Required</p> <ul style="list-style-type: none"> a) FH booster and hydrant system is to be upgraded to the degree necessary to comply with AS 2419.1 - 2021 in heavy including required statutory signage b) The booster shall be located in position readily accessible and further than 10m from non sprinkler protected building. <p>Does Not Comply / Further Information Required/ Performance Solution:</p> <ul style="list-style-type: none"> b) Location of internal fire hydrants located outside fire isolated stairs <4m from the exit does not comply. c) Hydraulic engineer will need to verify the performance of the system in terms of pressure and flows, compliant performance will need to be achieved where medium to heavy refurbishment works are proposed. <p>Does Not Comply/Rectification works Required</p> <ul style="list-style-type: none"> c) Pipework supports to be reviewed as part of any proposed re-purposing works particularly for internal pipework and upgraded in areas where works are proposed. <p>Does Not Comply/Rectification works Required</p> <ul style="list-style-type: none"> d) Coverage from existing FH outlets will need to be confirmed where shortfalls are identified then additional outlets may need to be introduced to provide sufficient coverage. <p>Does Not Comply/Rectification works Required</p> <ul style="list-style-type: none"> e) Statutory signage throughout should be upgraded as part of the proposed re-purposing works and ensuring all maintenance tags are provided.

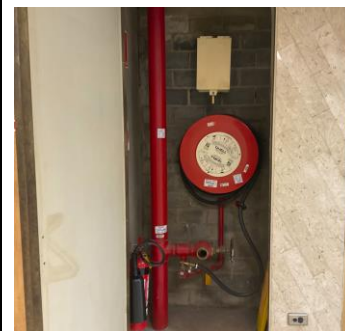
<p><i>Figure 88</i></p>

27.	<p>E1D3</p> <p>2019 Amdt 1 ref E1.4</p>	Fire Hose Reels	<p>The following comments are made with respect to the existing fire hose reels.</p> <ul style="list-style-type: none"> + No Fire Hose reels were installed within the basement car park. + A number of hose reels were located in corridors that had fire doors enclosing the space. Fire hose reels are not permitted to pass through fire doors. + Locations and clearances of fixtures to be reviewed by hydraulic consultant. + Signage to be upgrade to colour contrast in accordance with AS2441 - 2005. + Items other than for fire services installed within FHR cupboard. 	<p>Does Not Comply/Rectification works Required</p> <p>FHR coverage within basement car park area is required.</p> <p>Does Not Comply / Further Information Required/ Performance Solution:</p> <p>FHR on some levels had fire doors enclosing the space they are located within. This may be to protect FRNSW connecting to Fire hydrant located in the same cupboard noting they are not within fire isolated exit (see table). Fire hose reels are not permitted to pass through doors having a fire rating. Confirmation is required if corridor fire doors are intended to be kept as part of the refurbishment works.</p>

<p>It is recommended that fire hose reel coverage plans be provided to demonstrate compliance throughout the building any areas subject to proposed re-purposing works. Where existing outlets are located more than 4m from existing exits there may be scope under a Fire Engineered Solution to rationalise the existing locations consultation with a fire safety engineer will be required in this regard.</p> <p>This should also verify that compliant pressures and flows are achieved. Furthermore, it is recommended that signage to fire hose reel cupboards should be upgraded to comply with AS 2441-2005 and AS 2419.4-2021.</p> <p>Compliance Readily Achievable</p> <p>Fire hose reel signage and outlets to be modified to ensure required clearances are achieved in accordance with AS 2441-2005 and that all areas are provided with compliant coverage throughout.</p>

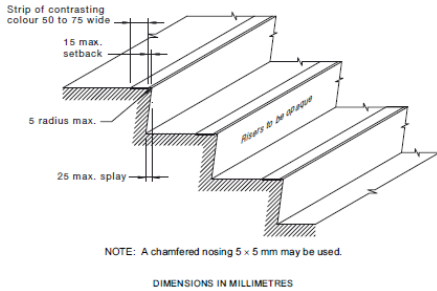
35.	<p>D3D14, D3D22 & D4D4</p> <p>2019 Amdt 1 ref D2.13, D2.17, D3.3 & AS 1428.1-2009</p>	General circulation stairways	<p>During the inspection there were various stairways including the nominated egress stairways were being utilised for general circulation purposes, and as such are required to comply with AS 1428.1-2009. General deficiencies throughout included;</p> <ul style="list-style-type: none"> + Lack of compliant colour contrasting nosing's to the stair treads and or not provided in accordance with clause 11 of AS 1428.1

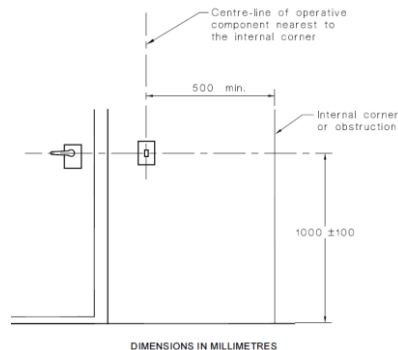
<p>b) Accessible sanitary compartments are required to be provided with rocker action toggle switches with a minimum dimension 30x30mm or a push pad with a dimension of 25mm. The existing switches were found to comprise a standard switch.</p>

<p>Figure 114</p> <p>Compliance Readily Achievable</p> <p>Existing switches would need to be replaced and or a sensor light will need to be provided to the accessible sanitary compartments throughout the building. Upgrade works of the existing would be required where the existing compartments are altered and or located on a path of travel.</p>

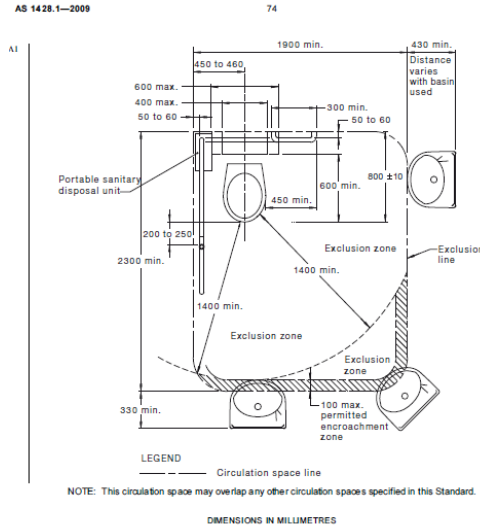
<p>Figure 131</p>
44.	<p>F4D5</p> <p>2019 Amdt 1 ref F2.4 & Cl. 15 of AS 1428.1</p>	<p>Accessible Sanitary Facilities</p>	<p>The existing building currently has a single accessible unisex facility located on ground floor only and no male or female facilities suitable for a person with an ambulant disability.</p> <p>AS 1428.1—2009 74</p>

<p>Figure 132</p>	<p>Does Not Comply/Rectification works Required</p> <p>Ground floor is the only storey that has a designated accessible unisex facility. BCA F2.4 requires accessible unisex facilities to be provided at 50% of the banks of each storey which would require an accessible unisex facility on each storey.</p> <p>Further Information Required:</p> <p>Upgrade works to the existing sanitary facility will be triggered where refurbishment works are proposed and/or where it is a project requirements. Upgrade works would entail provision of accessible unisex sanitary facilities on storeys facilities are provided and construction or repurposing of ambulant facilities to achieve the required clearances as per AS 1428.1.</p> <p>Wherever localised upgrade of existing facilities are required as a result of the proposed works ambulant facilities would need to be introduced to that bank of toilets to ensure compliance with the requirements of the BCA.</p>
