**NCC – ACCESS EXISTING CONDITION
REPORT**

**RAY WALSH HOUSE
(REFURBISHMENT)**

Tamworth Regional Council C/-
NSW Public Works

Revision: 0
13 April 2023
Reference: 230026

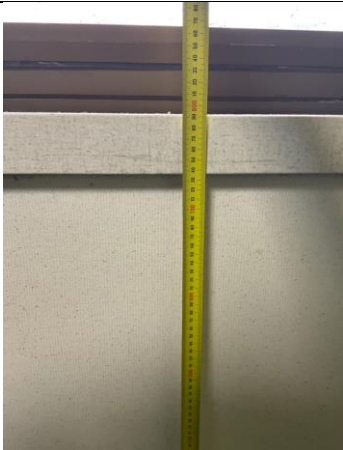
<p><i>Figure 16</i></p>

5.	C3D7 2019 Amdt 1 ref C2.6	Vertical separation of openings in external walls	<p>As the building is not sprinkler protected, vertical separation of openings (spandrel separation) in external walls is required in accordance with BCA cl. C3D7</p> <p>The building is not provided with compliant spandrel separation in several locations throughout the building and the makeup of the external walls in areas not known and likely would not achieve the required FRL under this clause i.e. 60/60/60.</p>	<p>Does Not Comply/ Further Information Required/ Performance Solution:</p> <p>Whilst makeup of external walls is unknown it was identified that some areas had >600mm upturn (approx. 800mm) the total 900mm and FRL 60 minutes would need to be confirmed.</p> <p>Parts of the building had glass screen/ curtain wall with non-combustible material within cavity e.g. metal flashing between storeys.</p> <p>Areas had what appeared to be vertical spandrel however appeared less than 1100mm with FRL to be confirmed.</p>

<p>Where the introduction of additional fire rated spandrels is not feasible, there may be scope for the spandrel separation to be considered under a fire engineering strategy through a mixture of horizontal and vertical fire rated elements and or the introduction of additional fire safety measures. This strategy would be subject to radiant heat calculations to demonstrate fire spread would not occur vertically via the façade further consultation will be required with a fire safety engineer in this regard.</p> <p>The above however would also require consideration of the type of external wall product installed within the building. Further consultation with a Fire Safety Engineer will be required as part of future design stages accordingly.</p>

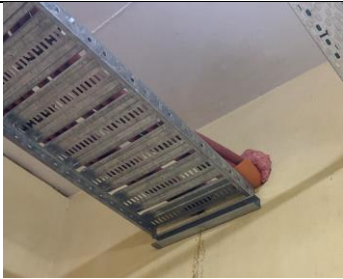
<p><i>Figure 29</i></p>

<p>The requirements of (2) apply where an electrical, electronic, plumbing, mechanical ventilation, air-conditioning or other service penetrates a building element (other than an external wall or roof) that is required to have an FRL with respect to integrity or insulation or a resistance to the incipient spread of fire.</p>	<p>Does Not Comply/Rectification works Required</p> <p>Existing floor and wall penetrations are to be upgraded to the degree necessary to ensure the new works comply.</p> <p>It is expected given the age of the building there will be numerous areas requiring rectification once ceiling is removed.</p> <p>The main switch board and other plant area had a number of defiance within requiring attention once FRL of elements passing is confirmed.</p>

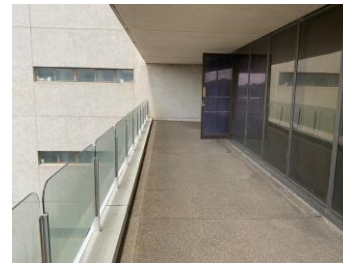
<p>Figure 34</p>

12.	D2D5 & D2D6 2019 Amdt 1 ref D1.4 & D1.5	Travel distances throughout	<p>Having regards to the number of available exits within the building, compliance with respect of travel distances is readily achievable generally throughout pending resolution of a number of items set out within this report.</p> <p>It is noted where partitioning is removed specific area this will improve egress arrangements.</p> <p>Notwithstanding the above, we note that there are existing extended travel distances within the building. Based on a scaled review of the existing architectural layouts provided by Tamworth Council approximate distances are noted as follows;</p> <ul style="list-style-type: none"> - Up to 35m to a point of choice in lieu of 20m from basement car park - Up to 30m to a point of choice in lieu of 20m from remaining storeys - Up to 36m to single exit in lieu of 20m on level 3. 	<p>Further Information Required:</p> <p>Travel distances will need to be reviewed in conjunction with the proposed works. The extended travel distances noted are based on the scale provided on the plans provided as such it is assumed to be accurate. Detailed scale plans along with basement, plant and machine room plans will need to be provided for assessment and review in order to verify the existing travel distances.</p> <p>The upper storeys have doors leading to external balcony. Confirmation is required if intended for public access or maintenance use only. It is not the space largely extends travel distance with two doors only around perimeter.</p> <p>Performance Solution:</p> <p>Notwithstanding the above, pending resolution of other BCA compliance matters pertaining to egress from the building it is considered that an upgrade strategy could be developed to achieve acceptable travel distances throughout under a mixture of a DTS and performance-based strategy.</p>

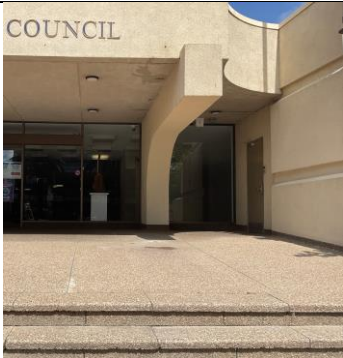
<p>Figure 48</p>

<p>Figure 45</p>
15.	D2D12 2019 Amdt 1 ref D1.7	Travel via fire isolated exits	<p>1) A doorway from a room must not open directly into a stairway, passageway or ramp that is required to be fire-isolated unless it is from—</p> <ul style="list-style-type: none"> a) public corridor, public lobby or the like; or b) a sole-occupancy unit occupying all of a storey; or c) a sanitary compartment, airlock or the like. <p>2) Each fire-isolated stairway or fire-isolated ramp must provide independent egress from each storey served and discharge directly, or by way of its own fire-isolated passageway—</p> <ul style="list-style-type: none"> a) to a road or open space; or b) to a point— <ul style="list-style-type: none"> i. in a storey or space, within the confines of the building, that is used only for pedestrian movement, car parking or the like and is open for at least 2/3 of its perimeter; and ii. from which an unimpeded path of travel, not further than 20 m, is available to a road or open space; or a) into a covered area that; <ul style="list-style-type: none"> i. adjoins a road or open space; and ii. is open for at least 2/3 of its perimeter; and 	<p>Further Information Required Does Not Comply/Rectification works Required / Performance Solution:</p> <ul style="list-style-type: none"> b) The basement car park has 2 x fire isolated exits that enter into same passageway in order to reach open space which does not comply with D2D12 (2). c) The peel street fire isolated exit discharges in front of GL unprotected openings glazed wall which does not comply with D2D12 (3). The glazed panel would require drenching or FRL 60 minute construction. d) The peel street fire isolated exits discharges undercover with 2.7m to underside of slab and 2.05m to underside of bulkhead. Plans would be required to demonstrate open for 2/3 perimeter in accordance with D2D12(b)(ii). e) The northern fire isolated stairs discharging into external car park on same allotment has alcove approx. 1.9m to underside of slab and is not open for 2/3 perimeter.

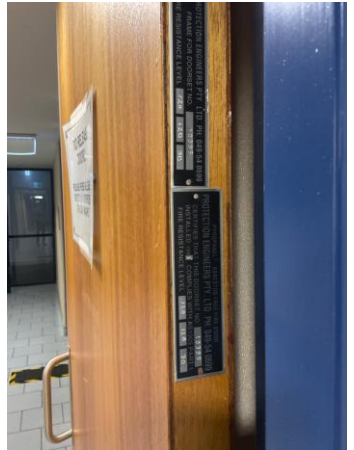
<p>Figure 53</p>

17.	D2D16 2019 Amdt 1 ref D1.10	Horizontal exits	<p>3) In cases other than in (2), horizontal exits must not comprise more than half of the required exits from any part of a storey divided by a fire wall.</p> <p>4) Horizontal exits must have a clear area on the side of the wall to which occupants are evacuating, to accommodate the total number of persons (calculated under D2D18) served by the horizontal exit of not less than— 0.5 m2 per person in any other case.</p> <p>5) Where a fire compartment is provided with only two exits, and one of those exits is a horizontal exit, the clear area required by (4) is to be of a size that accommodates all the occupants from the fire compartment being evacuated.</p>	<p>Further Information Required:</p> <p>It was noted during the inspection that some storeys had fire rated doors and masonry wall prior to reaching the fire isolated exits.</p> <p>Previous approval history or any existing fire engineering is not known whether the intent was to call this a horizontal exit. There where compliance issues associated with this and would need to be reviewed for suitability if intended to be relied on for refurbishment works.</p> <p>There was area on level 3 which was had fire doors either side of passageway however a glass panel breaking fire barrier.</p>

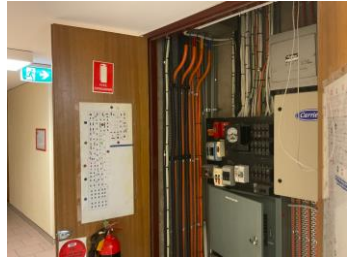
<p>Figure 55</p>

18.	D3D8 2019 Amdt 1 ref D2.7	EDB / Comms cupboards	<p>EDB/Comms cupboards are required to be smoke separated from the remainder of the building as required under D2.7 of the BCA. This includes the following.</p> <ul style="list-style-type: none"> + Provision of a non-combustible lining to the back of the enclosing door (gal sheet) + Smoke seals to the door and door jamb + Enclosing construction around the cupboard of non-combustible construction + Sealing of all penetrations within the bounding construction with a non- 	<p>Further Information Required:</p> <p>Access to all EDB/Comms cupboards etc. was not obtained during our inspection.</p> <p>In this regard, the relevant consultant (i.e. Electrician / Passive Fire Services Contractor) is to inspect all existing EDB/Comms cupboards and verify whether compliance with this clause is achieved.</p> <p>Does Not Comply/Rectification works Required</p> <p>EDB/Comms cupboards/enclosures inspected varied in compliance some with metal flash plate others only timber face doors. Multiple areas</p>

combustible product complying with AS 1530.1	<p>required penetrations to be upgrades as part of the works.</p> <p>Additionally there was locked electricity security room outside exist towards Kabel avenue which has ventilation louvers above door. The space was not accessible however needs to be reviewed against BCA D3D8.</p> <p>Complete smoke separated from the remainder of the building is required in conjunction with the proposed works and would dependant on the extent of refurbishment works. Where located within the zone of works it would be recommended that the cupboards are upgraded.</p> <p>Upgrade works would include sealing all perimeter gaps and penetrations with a non-combustible material, and lining of doors with a metal backing where existing doors not found to be fire rated doors.</p>

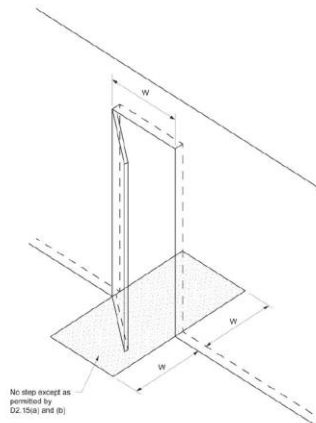
<p>Figure 65</p> <p>Location of thresholds to be reviewed in conjunction with proposed works to determine any upgrade works that may be required from an Access perspective. Refer comments later in this report accordingly.</p>

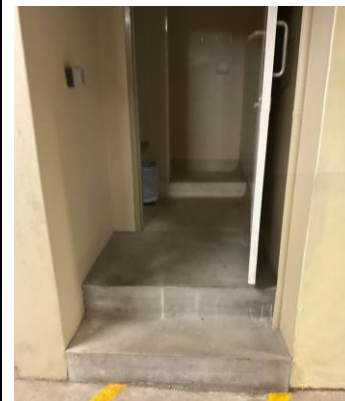
<p>Figure 69</p>
22.	<p>D3D17, D3D18, D3D19, D3D20</p> <p>2019 Amdt 1 ref D2.16</p>	Balustrades throughout	<p>There were a number of different balustrade types noted throughout the Ray Walsh building including masonry solid wall and varying metal types.</p> <ul style="list-style-type: none"> + Balustrades were less than 1m in height in numerous areas. This included exit locations, ramps, fire stairs and external glass balcony areas. + Openings within the balustrades were more than the maximum permitted 125mm. This included the level 4 upper external communal area, fire stairs gap between nosing line. + The existing balustrades resistance to human impact requirements under AS1170 could not be confirmed. The performance of the balustrades would need to be verified by a structural engineer. + Balustrades provided to areas located greater than 4m to the 	<p>Does Not Comply/Rectification works Required</p> <p>Depending on the extent of refurbishment works upgrade works to the existing balustrades may be required this will need to be workshopped as part of future design stages. Where works alter and/or are existing balustrades are located adjacent to or relied on for the new works upgrade works would be recommended.</p> <p>Note:</p> <p>Areas outside of the area of work should be reviewed as part of ongoing works within the building and by design team from a risk perspective.</p>

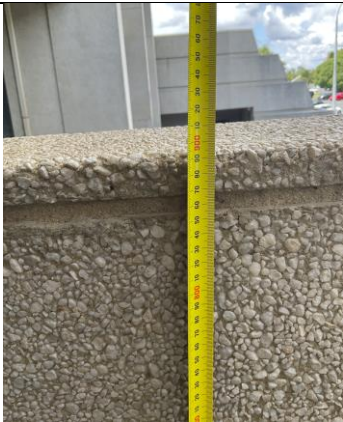
<p>Figure 71</p>

surface below were climbable and had horizontal elements located between 150-760 FFL

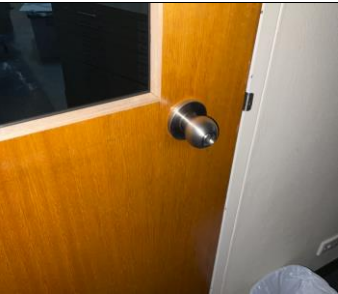
<p>Figure 74</p>

<p>Figure 73</p>
23.	<p>D3D24, D3D25 & D3D26</p> <p>2019 Amdt 1 ref D2.19, D2.20 & D2.21</p>	Doors and door hardware throughout	<p>a) A number of the required egress doors and doors located in a path of travel were noted as having door hardware which would not be readily openable for a person seeking egress including various locking mechanisms including doorknobs, snibs locks, drop down bolts and the like.</p> <p>b) Door hardware included various locking mechanisms with break glass alarms with associated electric strikes, given that all hardware throughout was not tested it was not clear whether the locking mechanisms would be openable for a person seeking egress at all times. These doors would need to trip in the event of a fire without the need to activate the break glass to achieve compliance.</p> <p>c) The failsafe device to the power operated entry door to the building will need to be confirmed no system testing was undertaken at the time of the inspection as such compliance could not be verified.</p>	<p>Compliance Readily Achievable</p> <p>a) Door hardware is required to be reviewed as part of any proposed works. Where located in a path of travel and/or required for egress purposes from the new part, door hardware will need to be rectified so that egress is readily available at all times for a person seeking egress</p> <p>Further Information Required:</p> <p>b) Power operated sliding doors is to be confirmed that it will auto open upon activation of smoke detection or power failure.</p> <p>c) The security drop bolt on ground level is to be reviewed noting required egress path to reach alternate exit.</p> <p>d) It is not clear whether the electric strike trips in the event of a fire, onsite testing would be required to confirm the operation of the fire trips in the event of a fire. To achieve compliance the trips will need to trip in the event of a fire.</p>

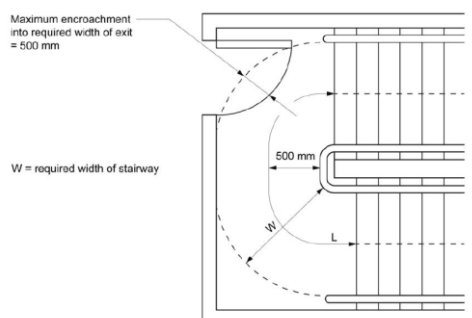
<p><i>Figure 75</i></p>

<p>d) Fire isolated exit doors encroachment onto landing to be reviewed for suitability.</p> <p>e) It is noted there is a vault installed on the 4th floor. Confirmation is required if space is to be repurposed in refurbishment.</p> <p>Does Not Comply/Rectification works Required</p> <p>f) Corridor fire door encroached over entry door to fire isolated exit.</p> <p>g) The Kabel Street GL exit door swings against the direction of egress which does not comply being the final exit door.</p> <p>h) The doors providing access to the fire isolated exits encroached >500mm onto stair width on door reviewed.</p>

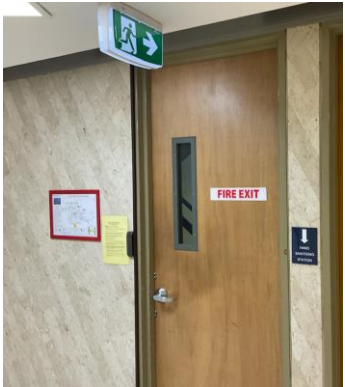
<p>Figure 79</p>

24.	D3D28 2019 Amdt 1 ref D2.23	Signs on Doors	<p>A sign referred to in (1) must be in capital letters not less than 20 mm high in a colour contrasting with the background and state the following:</p> <p>For an automatic door held open by an automatic hold-open device— FIRE SAFETY DOOR — DO NOT OBSTRUCT</p> <p>For a self-closing door— FIRE SAFETY DOOR DO NOT OBSTRUCT DO NOT KEEP OPEN</p> <p>For a door discharging from a fire-isolated exit— FIRE SAFETY DOOR — DO NOT OBSTRUCT</p>	<p>Does Not Comply/Compliance Readily Achievable</p> <p>Fire doors throughout would need signage to be reviewed in conjunction with refurbishment works. The fire doors within passageway had door tags only no signage, it should be confirmed if intended for re use in refurbishment works.</p>

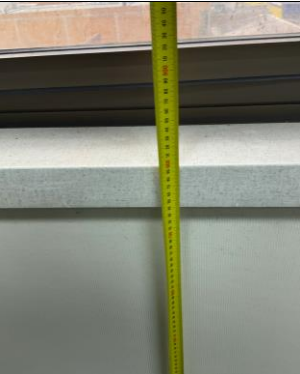
<p>Figure 82</p>

<p>b) have any horizontal or near horizontal elements between 150 mm and 760 mm above the floor that facilitate climbing.</p>

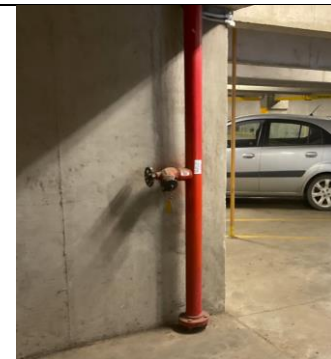
<p><i>Figure 87</i></p>

<p>system from a pressure and flow standpoint.</p> <p>e) Existing pipework supports are not fire rated and are located in a non-sprinkler protected building which would necessitate fire rated supports</p> <p>f) FH coverage throughout will need to be confirmed based on the location of the existing outlets to identify shortfalls within the existing building. Outlets in car park were noted to be located more than 4m from exits provided in paths of travel within the building rather than 4m from exits.</p> <p>Based on a review of the locations on site It appears as though there will be coverage shortfalls based on the existing conditions within the building and noting internal hydrants only provide coverage from a 30m hose with a 10m spray.</p> <p>g) FH outlets were located within internal cupboards and were not provided with compliant signage i.e. "Fire Hydrant" as per AS 2419 and AS 2441 maintenance tags would also need to be provided to all existing outlets.</p>

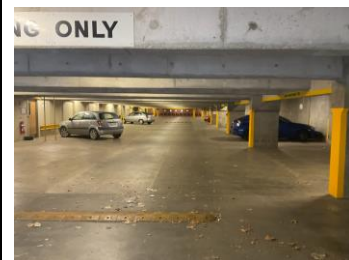
28.	E1D5 & E1D9 2019 Amdt 1 ref E1.5	Sprinklers	<p>Sprinklers are required where:</p> <ol style="list-style-type: none"> If any part of the building has an effective height more than 25m; and Within Class 7a car parks, sprinklers are required where more than 40 vehicles are accommodated. 	<p>Does Not Comply / Further Information Required/</p> <p>Confirmation by way of scaled elevations are required to confirm if the building effective heights exceeds 25m requiring sprinkler system. (See C2D3 also).</p> <p>The basement car park was noted to have in excess of 40 vehicles (approx. 49) and a sprinkler system was not installed. This is required to be reviewed in conjunction with refurbishment works where more than 40 cars proposed.</p>

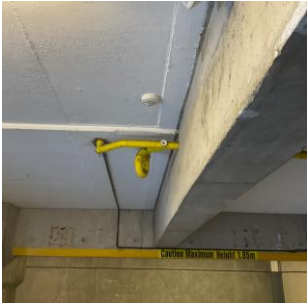
<p><i>Figure 93</i></p>

29.	E2D3, E2D4, E2D9(TBC) 2019 Amdt 1 ref E2.2	Fire detection and alarm system	<ol style="list-style-type: none"> The building having a RIS of more than three (3) is required to have a smoke detection throughout. Detection coverage shortfalls throughout including car park. Fire isolated stairway serving any storey above effective height of 25m OR fire isolated passageway with a length of travel more than 60m requires automatic air pressurisation system for the fire isolated exits in 	<p>Does Not Comply/Rectification works Required</p> <ol style="list-style-type: none"> There are numerous areas with coverage shortfalls including rooms not provided with detection to be reviewed by dry fire consultant. As part of any proposed upgrade works to the detection and alarm system it would be recommended that the external strobe be provided

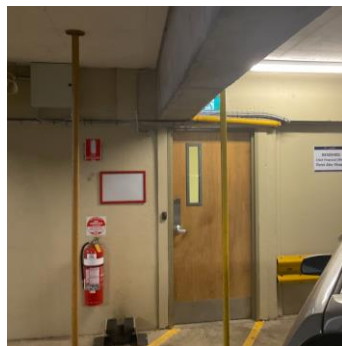
<p>Figure 96</p>

<p>Figure 95</p>
30.	<p>E4D2, E4D4, E4D5 & E4D8.</p> <p>2019 Amdt 1 ref E4.2, E4.4, E4.5 & E4.6</p>	<p>Emergency lighting and exit/directional signage – Throughout the building</p>	<p>Throughout the existing building there was emergency lighting coverage and exit and directional signage shortfalls which would need to be upgraded this is to ensure that all of the available exits are identified in line with the required exits to achieve the required travel distances.</p> <p>Exit signage would also need to be introduced to the internal courtyards to ensure that the egress routes are readily apparent for the occupants</p>	<p>Further Information Required</p> <p>The provision of emergency lighting and emergency exit and directional signage will be subject to further review as part of any proposed refurbishment works to suit new egress strategy.</p>

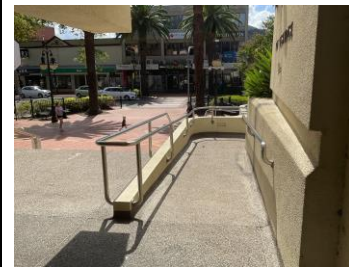
<p><i>Figure 100</i></p>

34.	D4D3 2019 Amdt 1 ref D3.2	Access to buildings	<p>An accessway must be provided to a building required to be accessible— from the main points of a pedestrian entry at the allotment boundary; and from any required accessible carparking space on the allotment.</p> <p>2) In a building required to be accessible, an accessway must be provided through the principal pedestrian entrance, and— through not less than 50% of all pedestrian entrances including the principal pedestrian entrance; and in a building with a total floor area more than 500 m², a pedestrian entrance which is not accessible must not be located more than 50 m from an accessible pedestrian entrance,</p>	<p>Does Not Comply/Rectification works Required Further Information Required/ Performance Solution:</p> <p>Access was provided by way of ramp from the Peel street entry point however this is no accessible entry point from Kabel avenue being further than 50m from accessible entry point.</p> <p>The ramp has aspects that did not comply with AS1428.1 being 90 degree turn space being less than required. Overall gradient to be confirmed.</p> <p>There was no accessible car parking provided (See D4D6) however if this was to be provided within existing basement car park there is not an accessway to reach pedestrian lifts.</p> <p>Further review will be required once scope of refurbishment is defined.</p> <p>Compliance Readily Achievable</p>

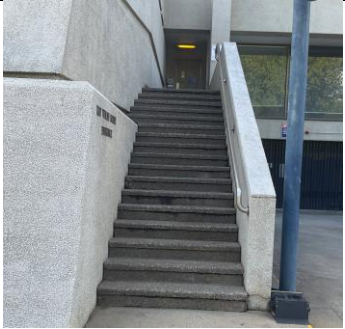
<p>Figure 104</p>

<p>Figure 103</p> <ul style="list-style-type: none"> + No tactile ground surface indicators (TGSi) installed at a number of the stairways throughout at the top, bottom and mid landing of flights as per BCA cl. D3.8 and Section 9 of AS 1428.1-2009. 	<p>Compliance Readily Achievable</p> <p>Requirement for upgrading of each respective stairway will be determined according to the proposed re-purposing works in conjunction with the affected part assessment.</p> <p>Where egress stairways are to be utilised for general circulation purposes in addition for egress purposes they are recomended to be upgraded to comply with the requirements of AS1428.1 based on the conditions at the time of the inspection these works would be considered to be minor in nature including provision of tactile indicators, nosing strips and a finish which will provide a suitable non-slip finish.</p> <p>Noting the number of stairways within the building are deemed to be fire isolated and for egress only this shall be confirmed. Notwithstanding upgradings items such as colour constradst nosings can be readily achiiveed at minimal cost.</p>

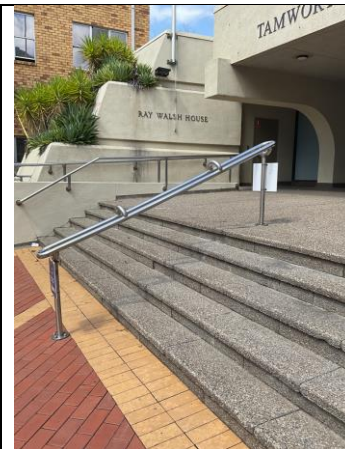
<p>Figure 106</p>

<p>+ Slip rating of the existing finishes to the stairways including landings is not known based on a visual inspection further onsite testing would be required accordingly</p>

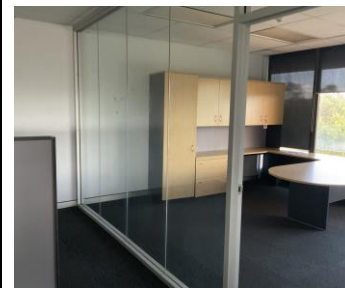
<p>there were areas within staff areas and classrooms which would not provide sufficient space for wheelchair access as required under AS 1428.1.</p> <ul style="list-style-type: none"> + The existing slip rating of floor surfaces throughout could not be verified during the inspection. Based on the visual inspection of the various surfaces to the existing stairways it is likely that the finishes will not achieve a compliant slip rating. + Threshold steps were noted in a number of locations throughout the building including doors leading to external spaces which did not comply + Existing door hardware to sliding doors are not of a compliant type is. D handle type. <p>Typically there were no glass decals provided to various glazed assemblies located along the accessible path of travel. A glass decal minimum of 30% luminance contrast 75mm wide located between 900-1000mm is required to be provided to all frameless glazed sidelights doors windows which can be mistaken for a doorway opening.</p>	<p>h) Multiple doors widths and paths do not comply with AS1428.1 – ref later in the report.</p> <p>i) Visual indicators (glass decals) will need to be upgraded throughout. Where located on the affected part upgrade works will be required as part of any proposed works within the building.</p> <p>Further Information Required/</p> <p>Confirmation is required if the external balcony areas are intended to be public access or restricted to maintenance only for roof. It is noted where public access is required there is no DDA access, travel distance, balustrades do not comply and hydrant coverage will need to be reviewed.</p>	<p><i>Figure 108</i></p>

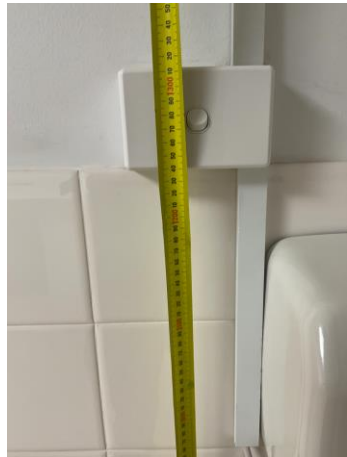
<p>Figure 115</p>

<p>Figure 113</p>
37.	CI 14 AS 1428.1-2009	Internal switches / Controls - Throughout	<p>a) During the inspection, a number of switches and controls were located less than 900mm or more than 1.1m above finished floor level and also less than 500mm from internal corners and or objects which obstruct access to and use of the door controls as such they would not comply with Section 1 4 of AS 1428.1-2009. All door controls, lighting controls and all controls other than general purpose outlets are required to comply with the above. Switches to the existing accessible sanitary compartments where non-compliant also a number of the card readers and push-button door openers were installed within 500mm of internal wall corners and objects obstructing access.</p>	<p>Compliance Readily Achievable</p> <p>a) Electrical contractor to undertake a detailed inspection of all internal switches / controls (such as door access swipes), and where required, reposition switches in accordance with the requirements of Section 14 of AS 1428.1-2009 where ever located on the affected part and within the new work zones noting that all new works will also need to comply</p>

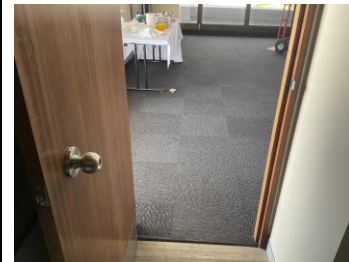
<p><i>Figure 128</i></p>

43.	Cl. 13 AS 1428.1-2009	Doorway clearances/ hardware and Circulation space - Throughout	<p>a) A number of the existing doors throughout the building did not achieve a clear unobstructed width of 850mm as required by AS 1428.1-2009 this includes to any openable leaf of a double door set,</p> <p>b) A number of the doorways did not achieve compliant latch side clearance based on location of adjoining nib walls columns within corridors, hinge side clearances.</p> <p>c) Where self-closers were fitted to doors other than fire doors maximum force to open the door is not to exceed 20N it was not clear whether the existing doors would comply in this regard.</p> <p>d) Door hardware was installed onsite was found to be of the type which would not slip in the event of a person using the hardware. i.e. D handle this was found in a number of</p>	<p>Does Not Comply/Rectification works Required</p> <p>Performance Solution:</p> <p>a) The extent of upgrade works to the existing doorways will depend on the proposed areas of work in the future and the 'Affected Part' upgrade requirements to be determined as part of future design stages. Where there is a double door set with an encroachment on the active leaf less than 850mm there may be scope under a performance solution to rationalise the width through operational management strategies. Otherwise rectification works will be required</p> <p>Does Not Comply/Rectification works Required</p> <p>b) A number of the rooms which are not provided with compliant circulation space, There is also potential scope to rationalise access requirements under a performance solution where there are alternative areas which are accessible and offer the same functions within the</p>

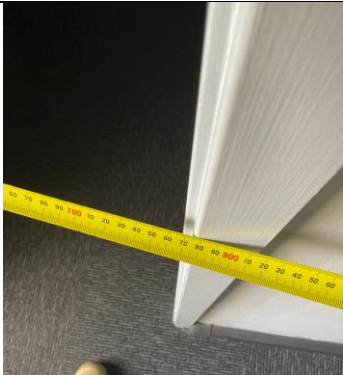
<p><i>Figure 129</i></p>

<p>(b) Plan view</p> <p>FIGURE 35(A) EXAMPLE OF ACCEPTABLE DOOR HARDWARE FOR HINGED DOORS</p> <p><i>Figure 127</i></p>	<p>building. The upgrading of the existing doorways will need to be confirmed based on any affected part triggers which may apply based on the proposed works.</p> <p>Does Not Comply/Rectification works Required</p> <p>c) Testing of the self closer would be required to confirm compliance it appears a number of the doors would exceed this limit based on the conditions on site. Upgrading would be triggered as part of the affected part upgrade works</p> <p>Does Not Comply/Rectification works Required</p> <p>d) Door hardware would need to be reviewed throughout in conjunction with the proposed works where located on the affected part the hardware will need to be upgraded accordingly</p>

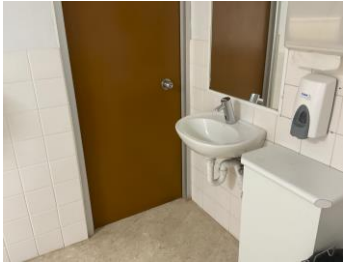
<p>Figure 135</p>

<p>Figure 131</p>
44.	<p>F4D5</p> <p>2019 Amdt 1 ref F2.4 & Cl. 15 of AS 1428.1</p>	<p>Accessible Sanitary Facilities</p>	<p>The existing building currently has a single accessible unisex facility located on ground floor only and no male or female facilities suitable for a person with an ambulant disability.</p> <p>AS 1428.1—2009 74</p>
